Near-Miss Electrical Accident at DOE Headquarters

HS-32

October 5, 2009

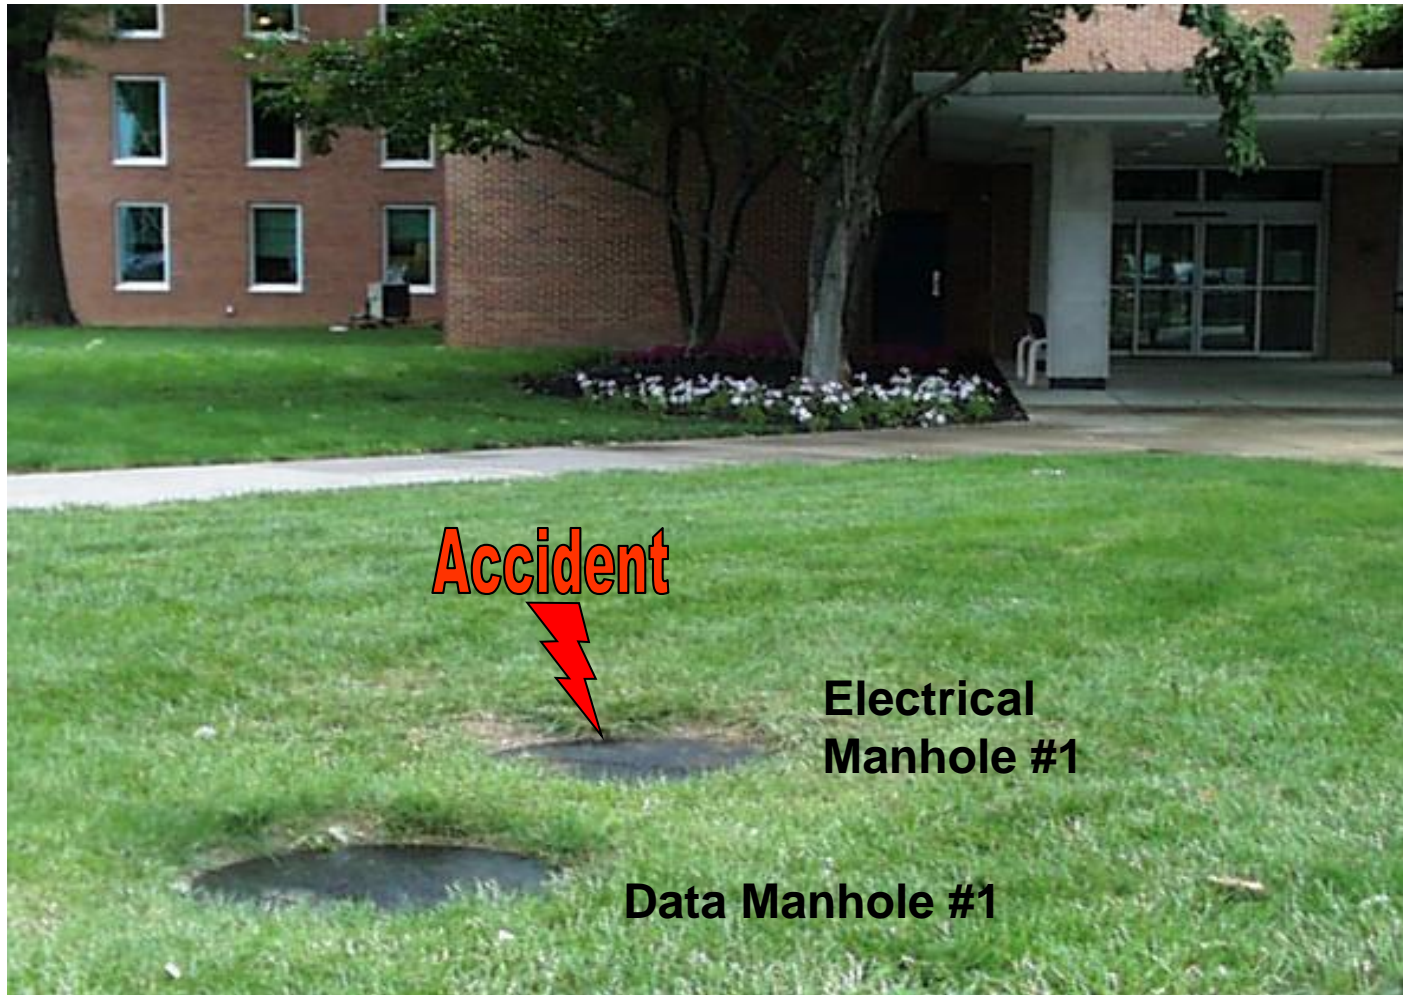
Manholes at South Entrance

Accident

**Electrical
Manhole #1**

Data Manhole #1

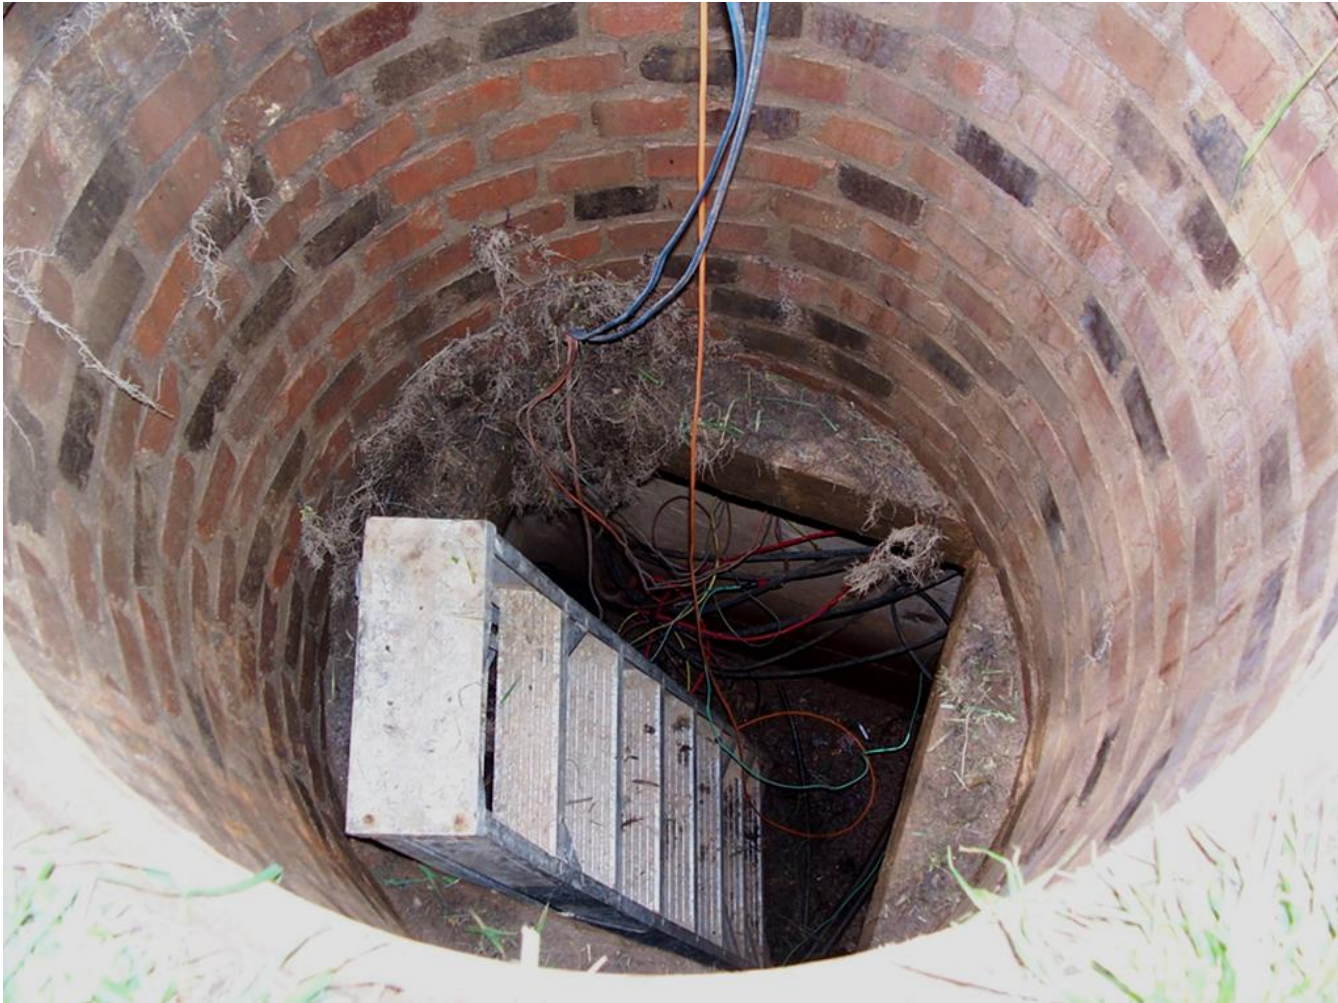
Electrical Manhole #1

- The fiber-optic cable being replaced was located in the same conduit as the 480-volt electric cable that supplies power to the camera transformer.
- A separate, 480-volt, 3 phase, electrical service for the radio building was in the bottom of the manhole.
- The lower electrical junction box at Camera 126 contained exposed energized electrical terminals with 480 volts electrical phase-to-phase potential.

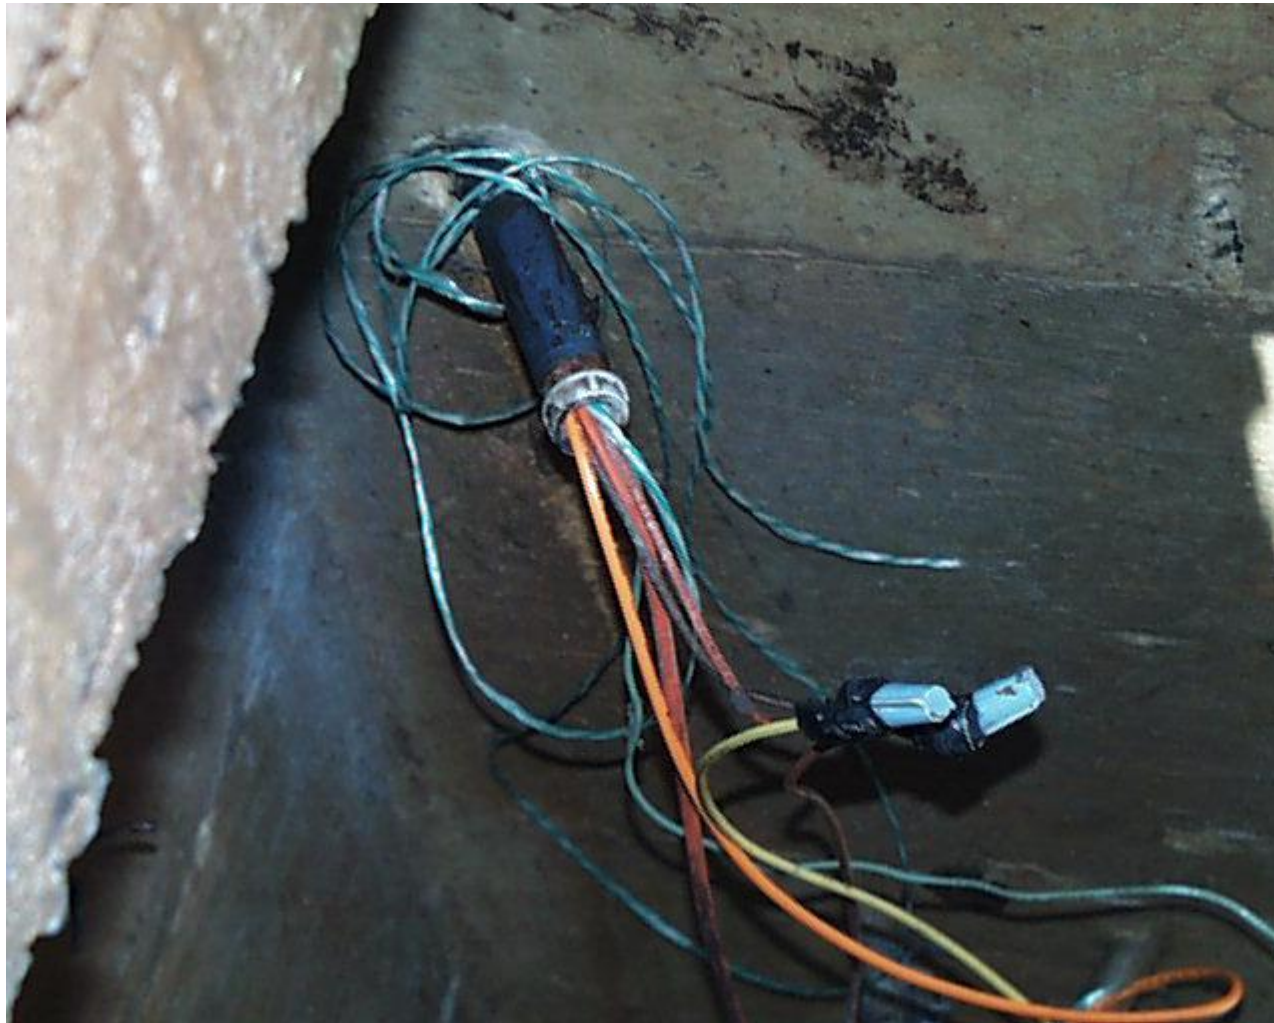
Manhole #2

Conduit to Camera

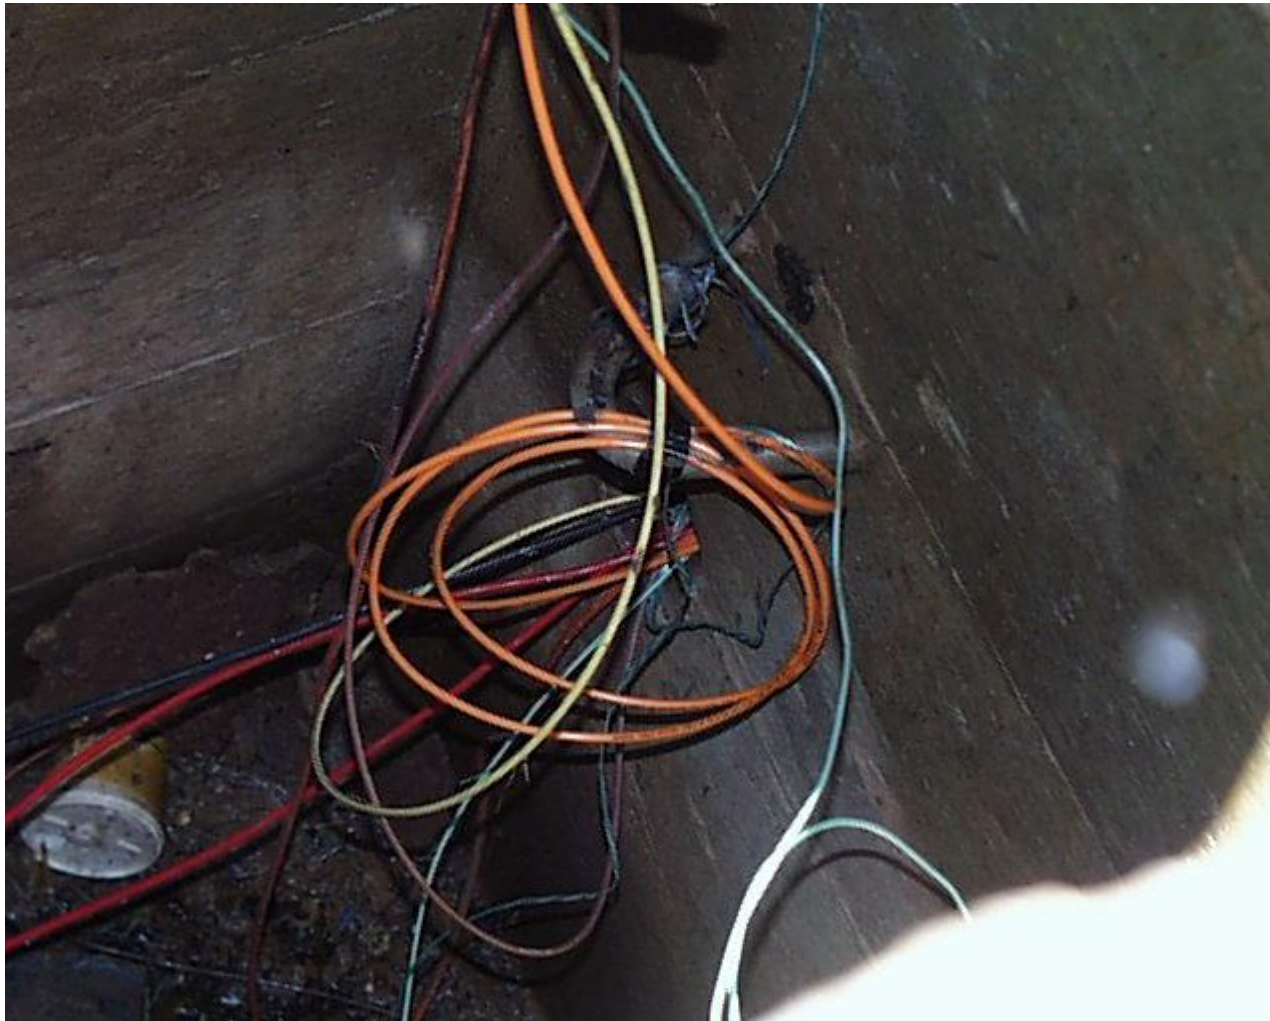
Manhole #2

Conduit to Manhole #1

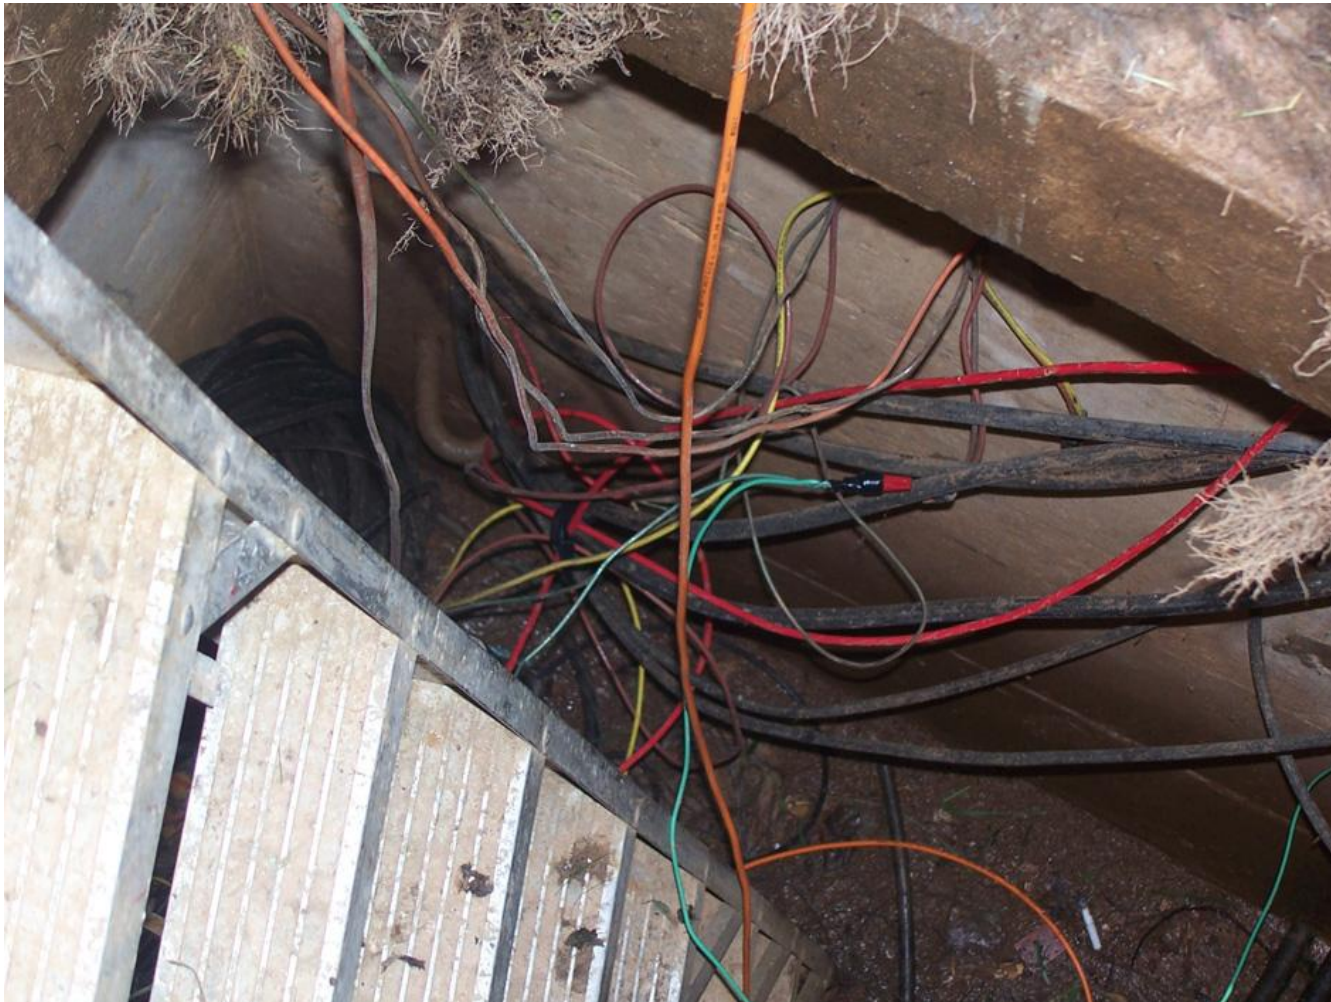
Manhole #1

Wiring and Cables

- ⚡ Contact with an exposed energized conductor; either one of the three-phase (480-volt) electrical cables or the single-phase (480-volt) electrical cables located in the manhole.
- ⚡ Damage to the single-phase 480-volt cable by the ground wire.
- ⚡ Disconnecting the ground wire.

A more definitive determination of the direct cause is not possible at this time because the manhole is not safe to enter. The manhole has been secured to prevent unauthorized entry until the electrical hazard can be abated.
