Lessons To Be Learned From BP Deepwater Horizon

Bill Rigot

Savannah River Nuclear Solutions

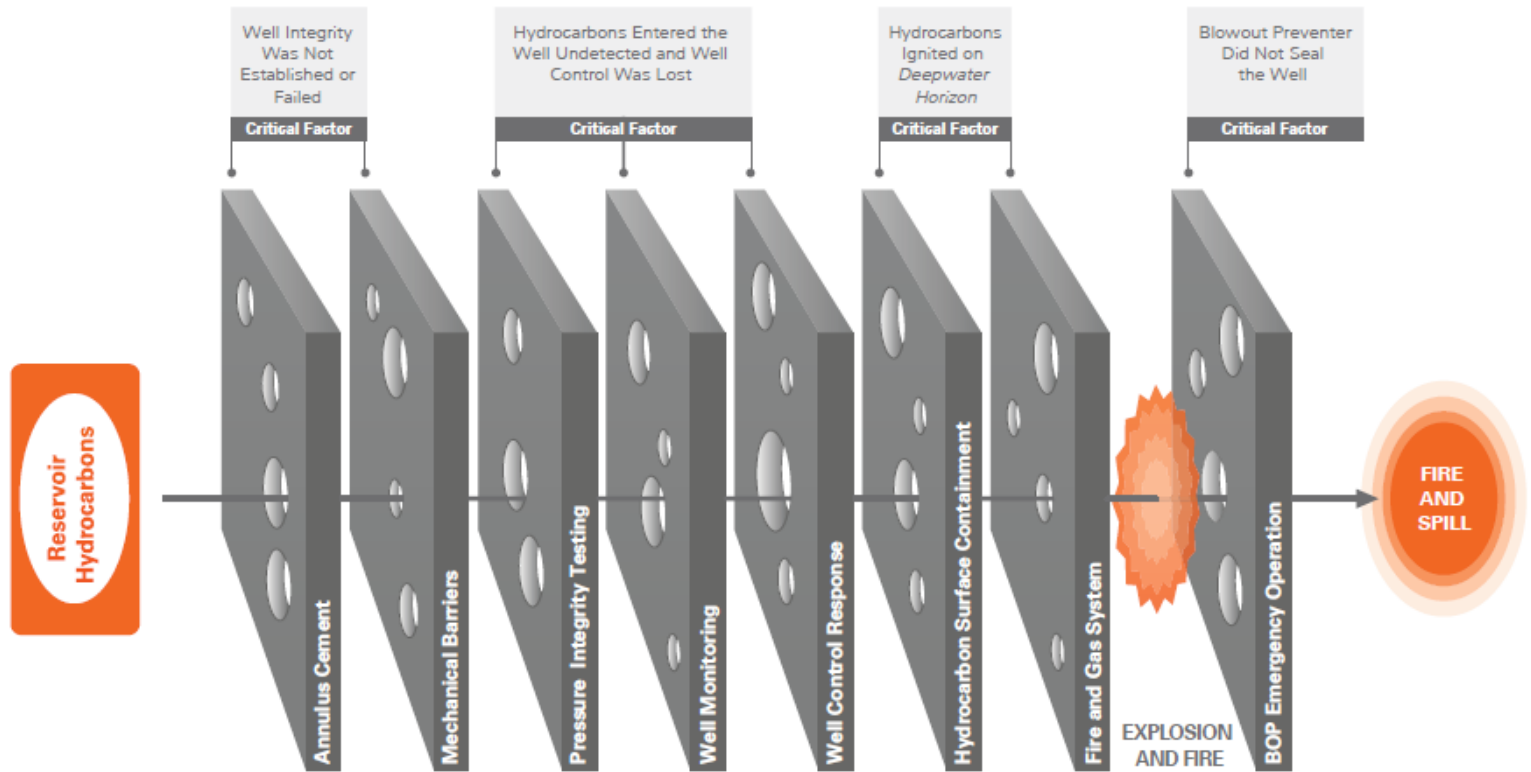
Figure 1. Barriers Breached and the Relationship of Barriers to the Critical Factors.

Causal Factors Identified by BP

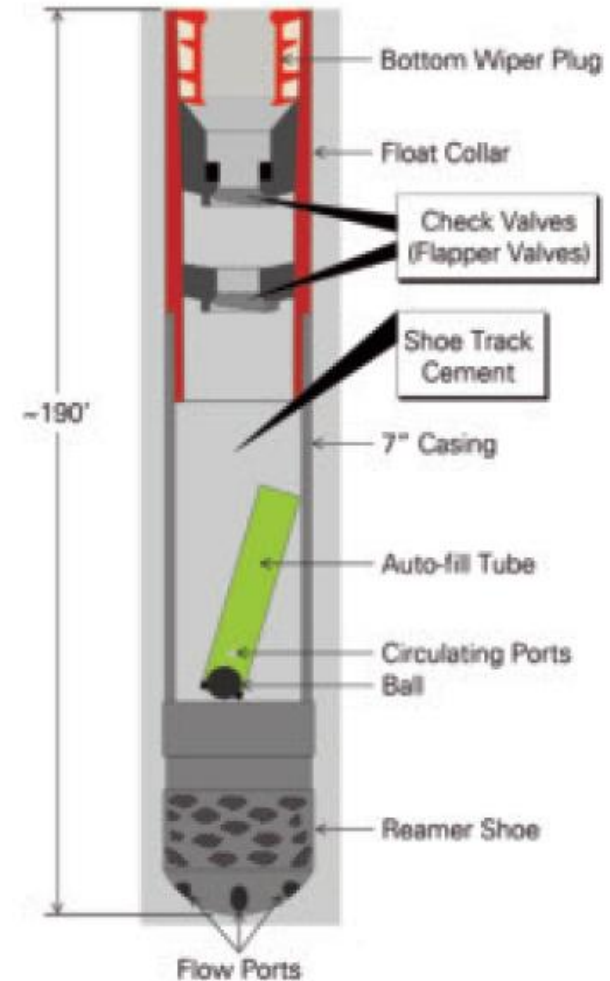
Shoe Track Barrier Failure

- Both the shoe track cement and the float collar failed to allow hydrocarbons up the wellbore
- Potential common mode failure with failure of the annulus cement barrier

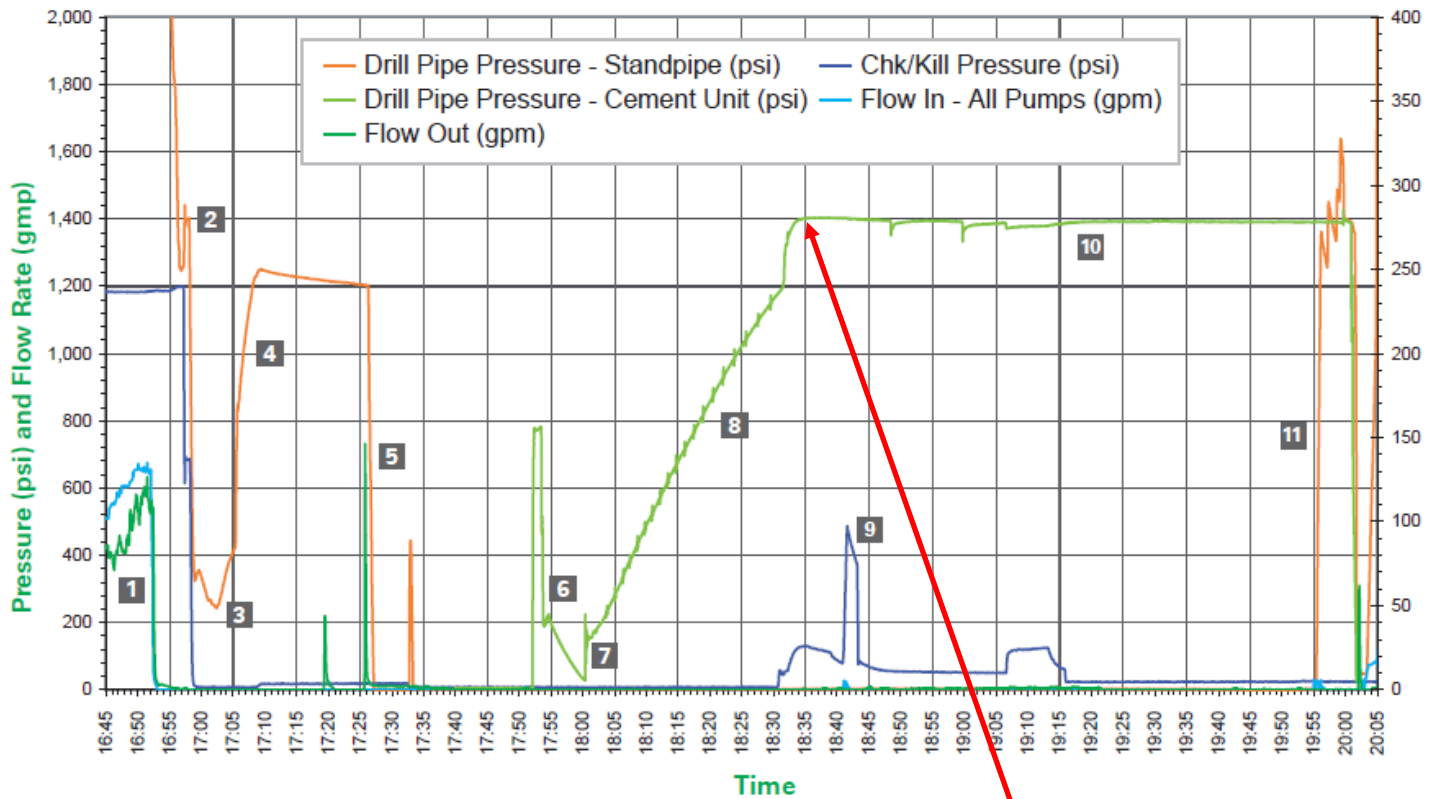
Negative Pressure Test Interpretation

Critical interpretation anomaly

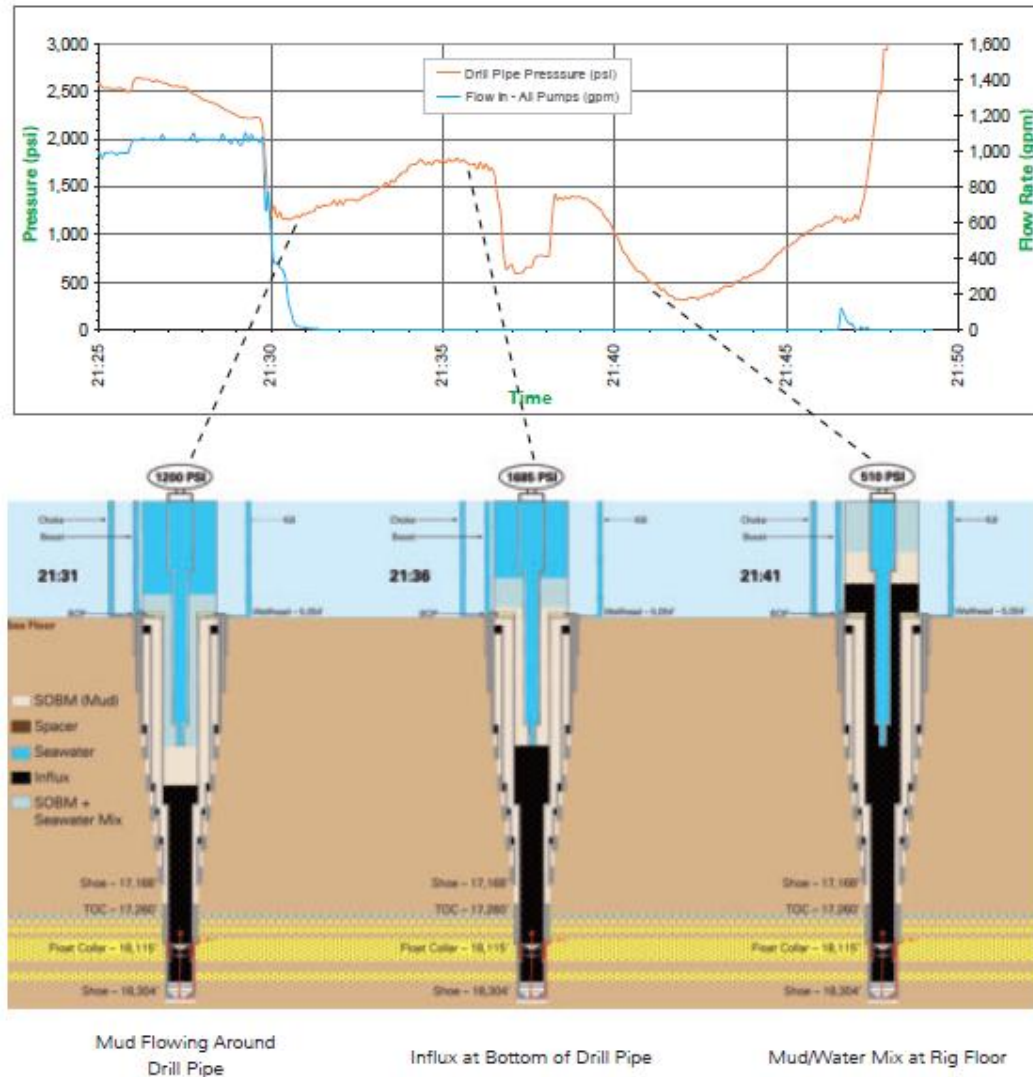
Figure 16. Modeled Pressure Responses Resulting from Hydrostatic Changes in the Wellbore.

Influx Not Recognized

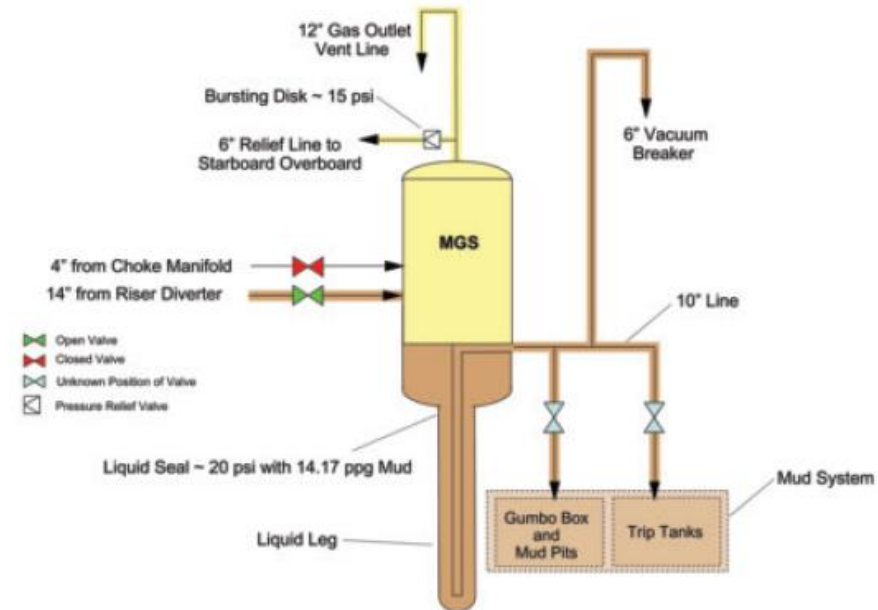
Mud Gas Separator Design

- From the MGS hydrocarbons vented directly into the rig through a 12 inch goosenecked vent
- This design feature was not understood by the operators

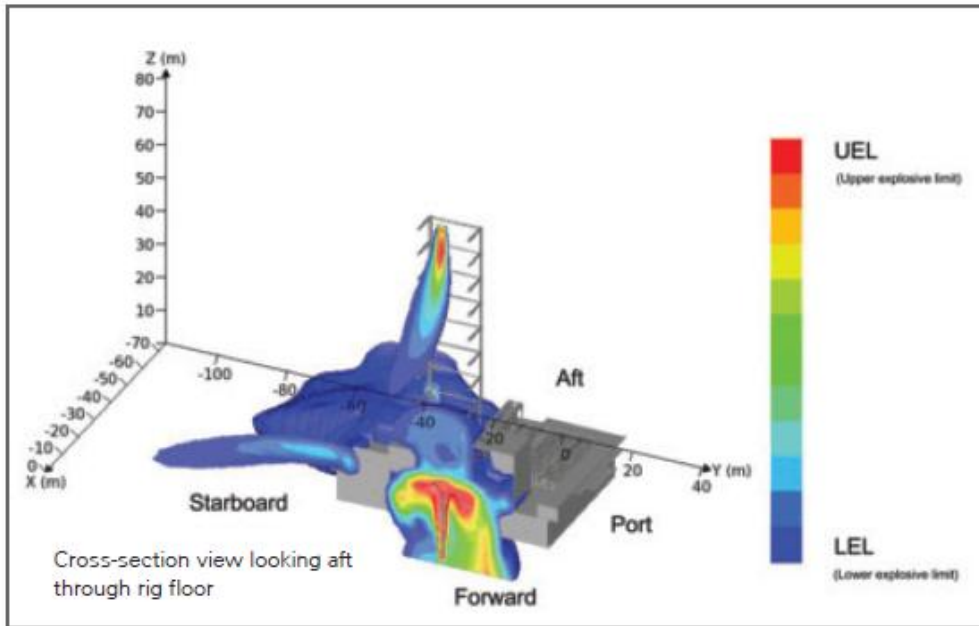
Figure 10. Vapor Dispersion at 240 Seconds.

Fire and Gas system Design
