Lessons Learned from a Tc-99 Glovebox Deflagration at a Chemical Laboratory

In June 1999, a glovebox in the Chemical and Metallurgical Research (CMR) facility over-pressurized, bursting a glove and releasing high levels of Tc-99 contamination into a laboratory room. Fortunately, this particular room was unoccupied at the time, and no personnel contamination or injuries occurred.

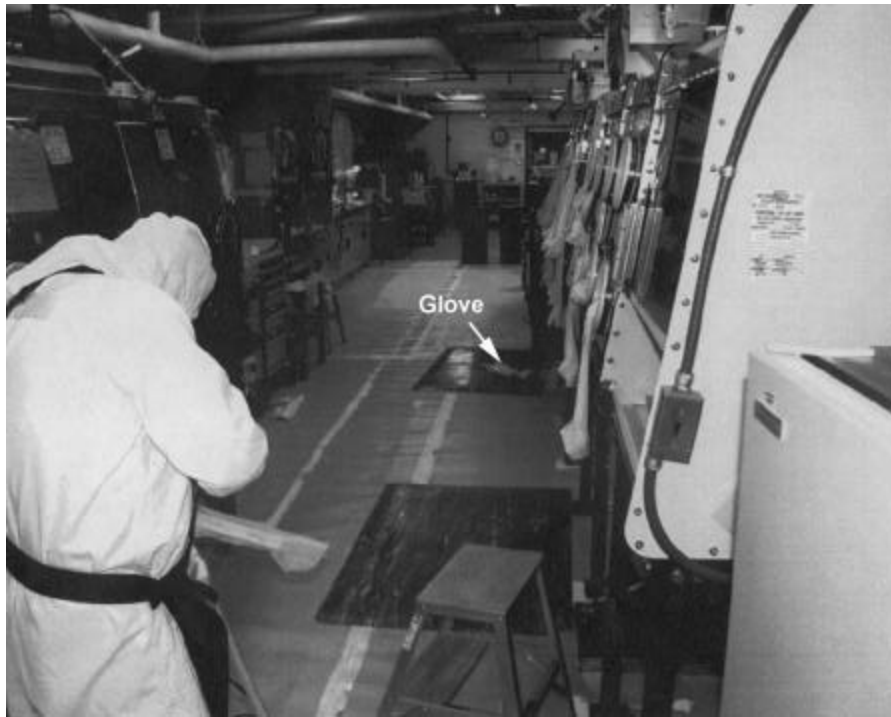
Between 1400 and 1430, the first responders in the PORTS work area, looking past the yellow laser curtain, noted that a low-lying white haze had filled the laboratory room. This haze also cleared during this time period. Later, the responders discovered that the left glove in the upper-middle set of gloves in one glovebox had “blown off” (Figure 1). Response personnel subsequently plugged this glove port (Figure 2).

Figure 1, Laboratory Room showing the glove on the floor following the incident

- After the glove was blown off, Tc-99 contamination was released into the laboratory and evenly distributed throughout the room.

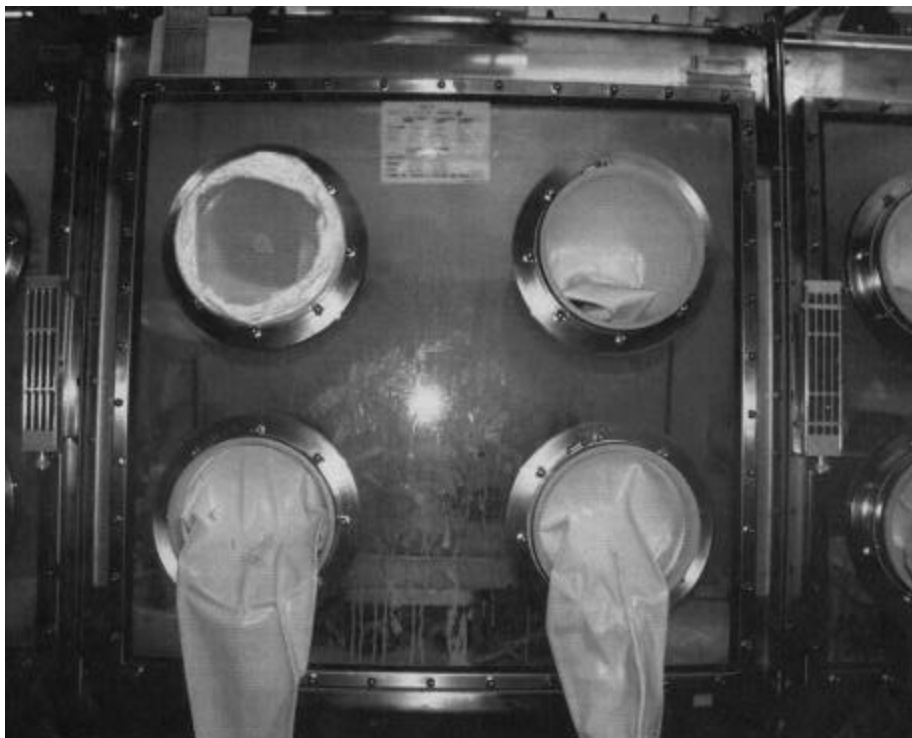
Figure 2, Glovebox with glove port plugged following the incident.

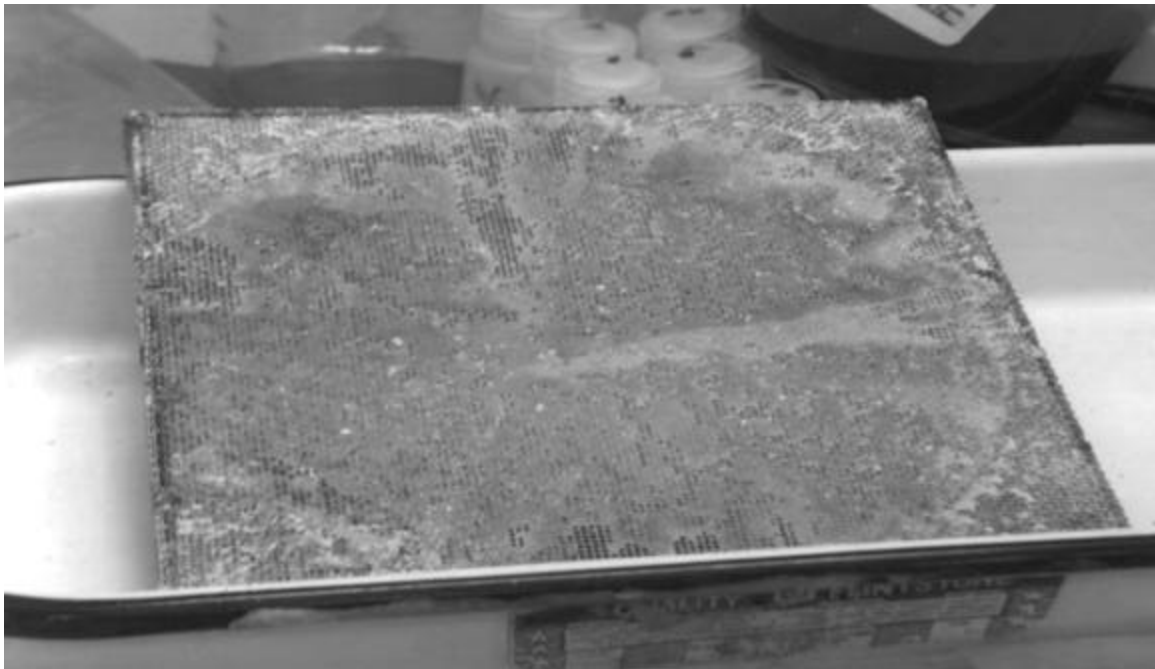
The materials on the two fire screens were analyzed and found to have molar ratios of nitrate to ammonium ion of 1.1 and 1.0 respectively, indicating the material was essentially ammonium nitrate, with a slight enrichment of nitrate. This ratio is slightly different than the 1.2 ratio that was found in the sample liquid.

- Partial clogging of the fire screens and/or exhaust HEPA filters would facilitate the pressurization of the glovebox during a rapid generation of gasses. It is less likely that partial clogging would prevent the release of a slow buildup of pressure. The glovebox inlet HEPA filters were examined after the incident and found relatively free from residue buildup. Although some moisture buildup (from the evaporation process) may have impeded flow through these filters, they should have served to vent pressure unless there was a rapid generation of gasses in the glovebox.

The fire screens and outlet HEPA filters were removed from both gloveboxes. Inspection of the fire screens in both boxes revealed that the screens were almost completely clogged with solid residues. Inspection of the HEPA filters showed that the material in the upstream side of the filters was significantly deformed and thus allowed a significant flow of air through the filter media (Figures 3 and 4).

Figure 3 Glovebox fire screen following the incident.

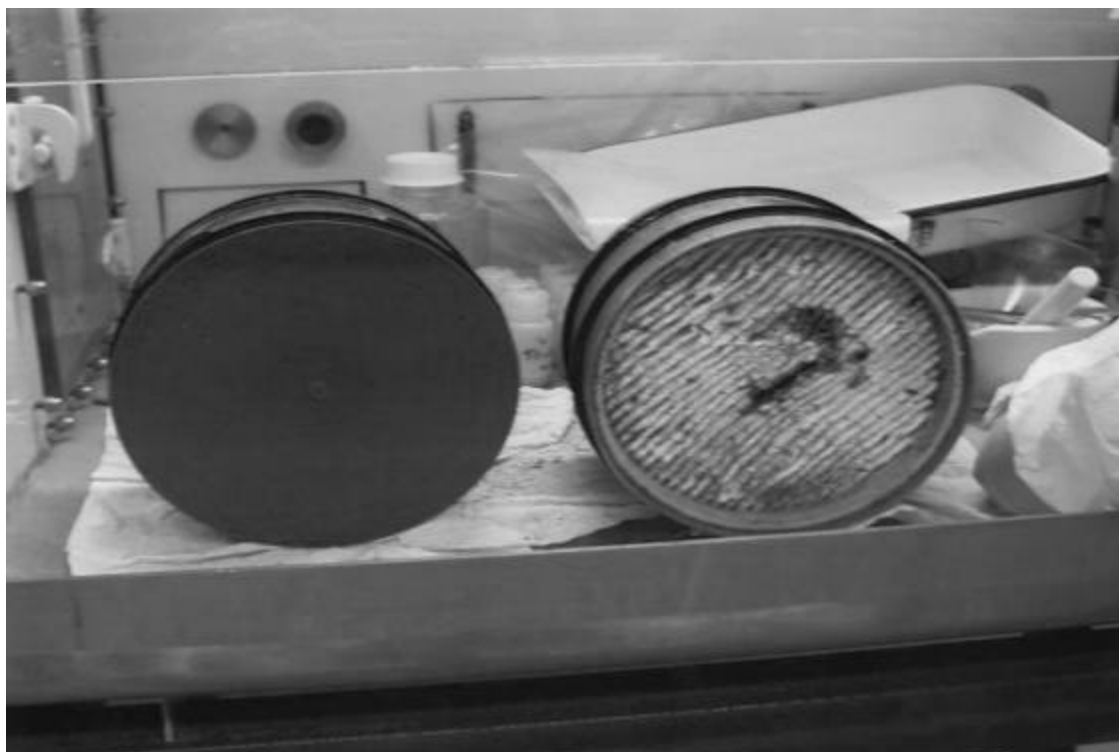
Figure 4 Glovebox HEPA following the incident
