IDENTIFY BEST PRACTICES FOR EXCAVATION AND D&D RELATED TO ELECTRICAL SAFETY

EFCOG Initiative # 6

July 16-20, 2007

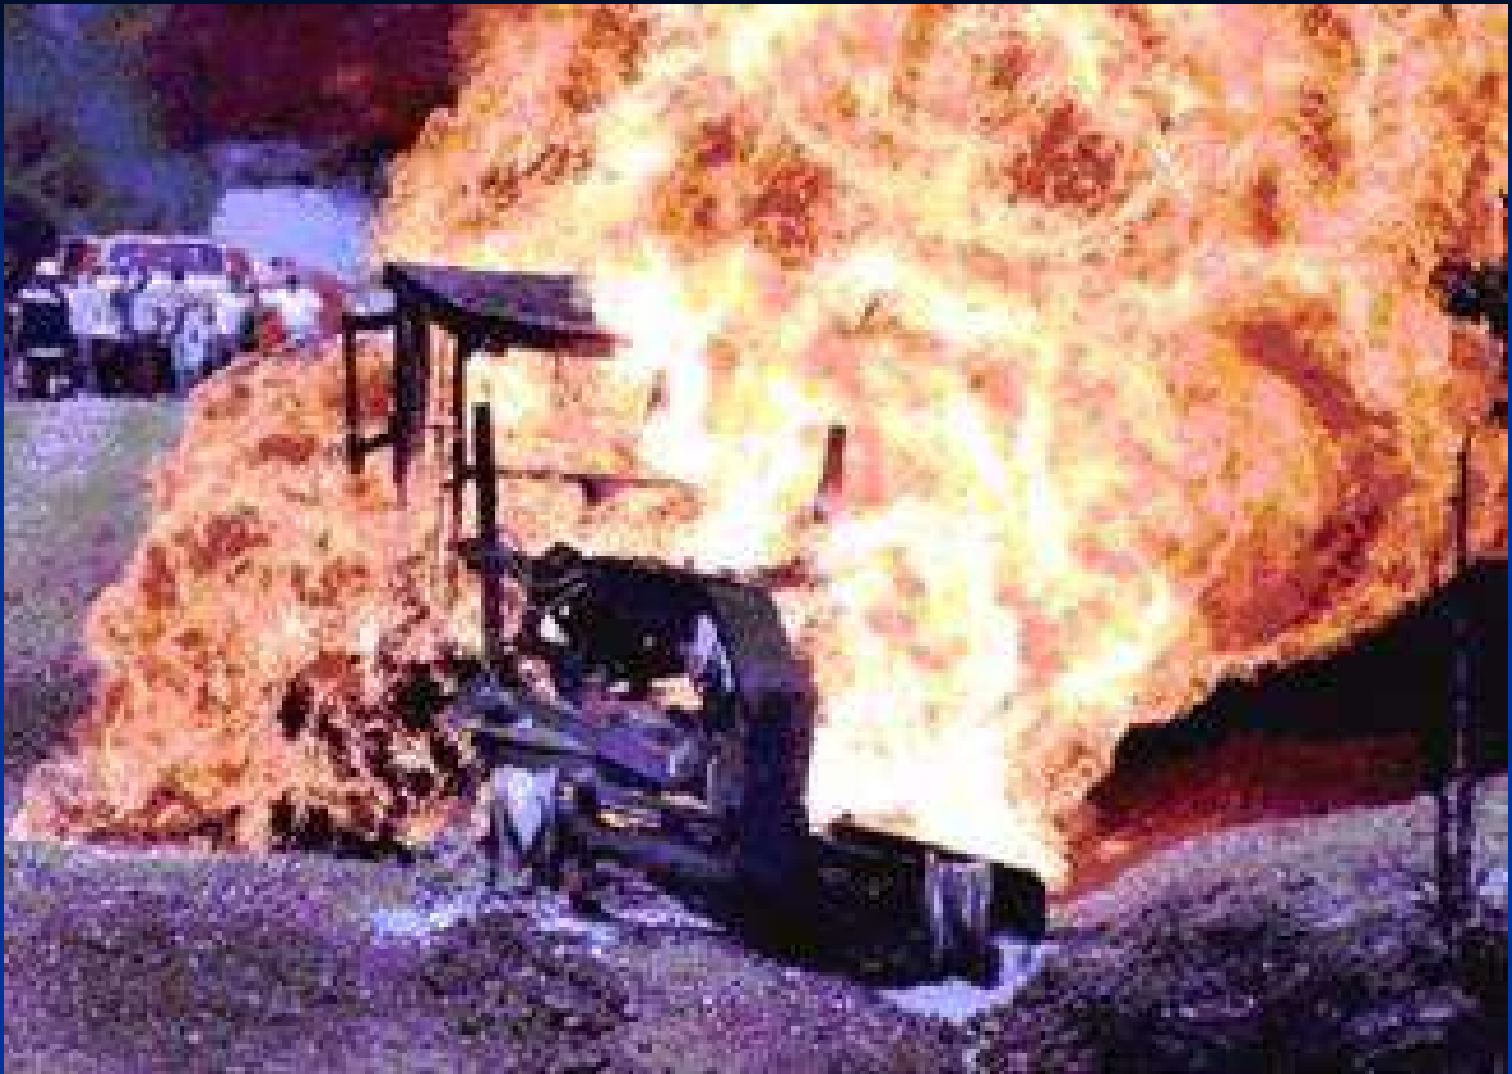
Figure 2-1. Road grader engulfed in flames

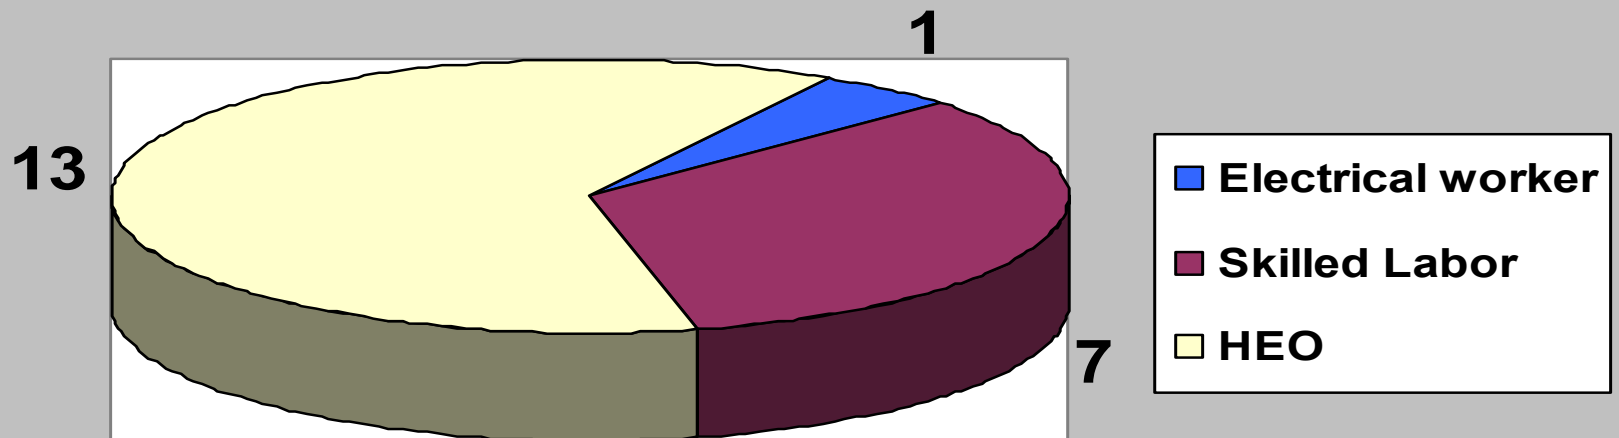
Figure 1. Who

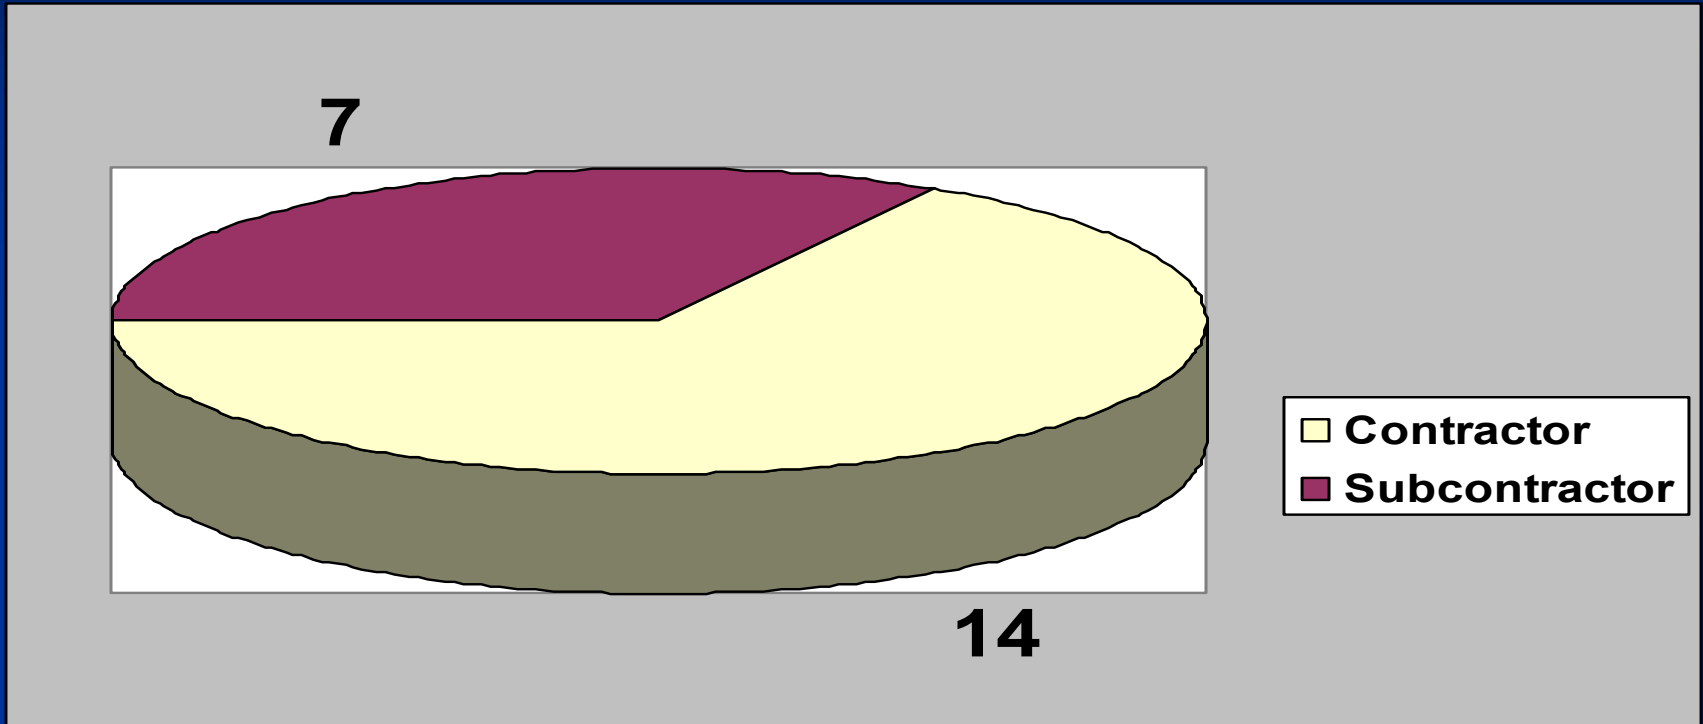
Figure 2. Contractor Vs subcontractor

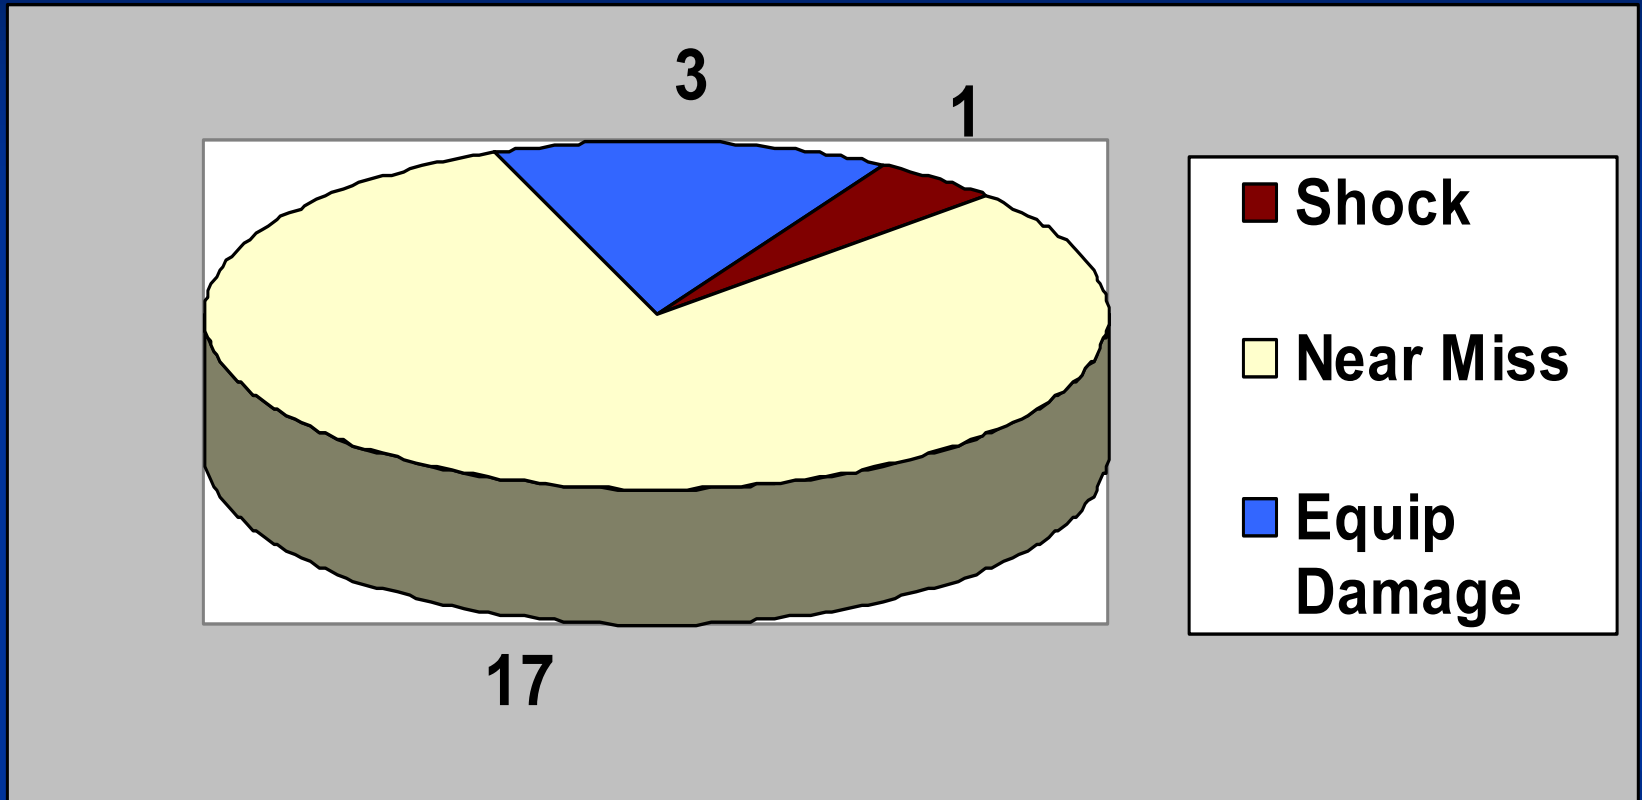
Figure 3. Consequence

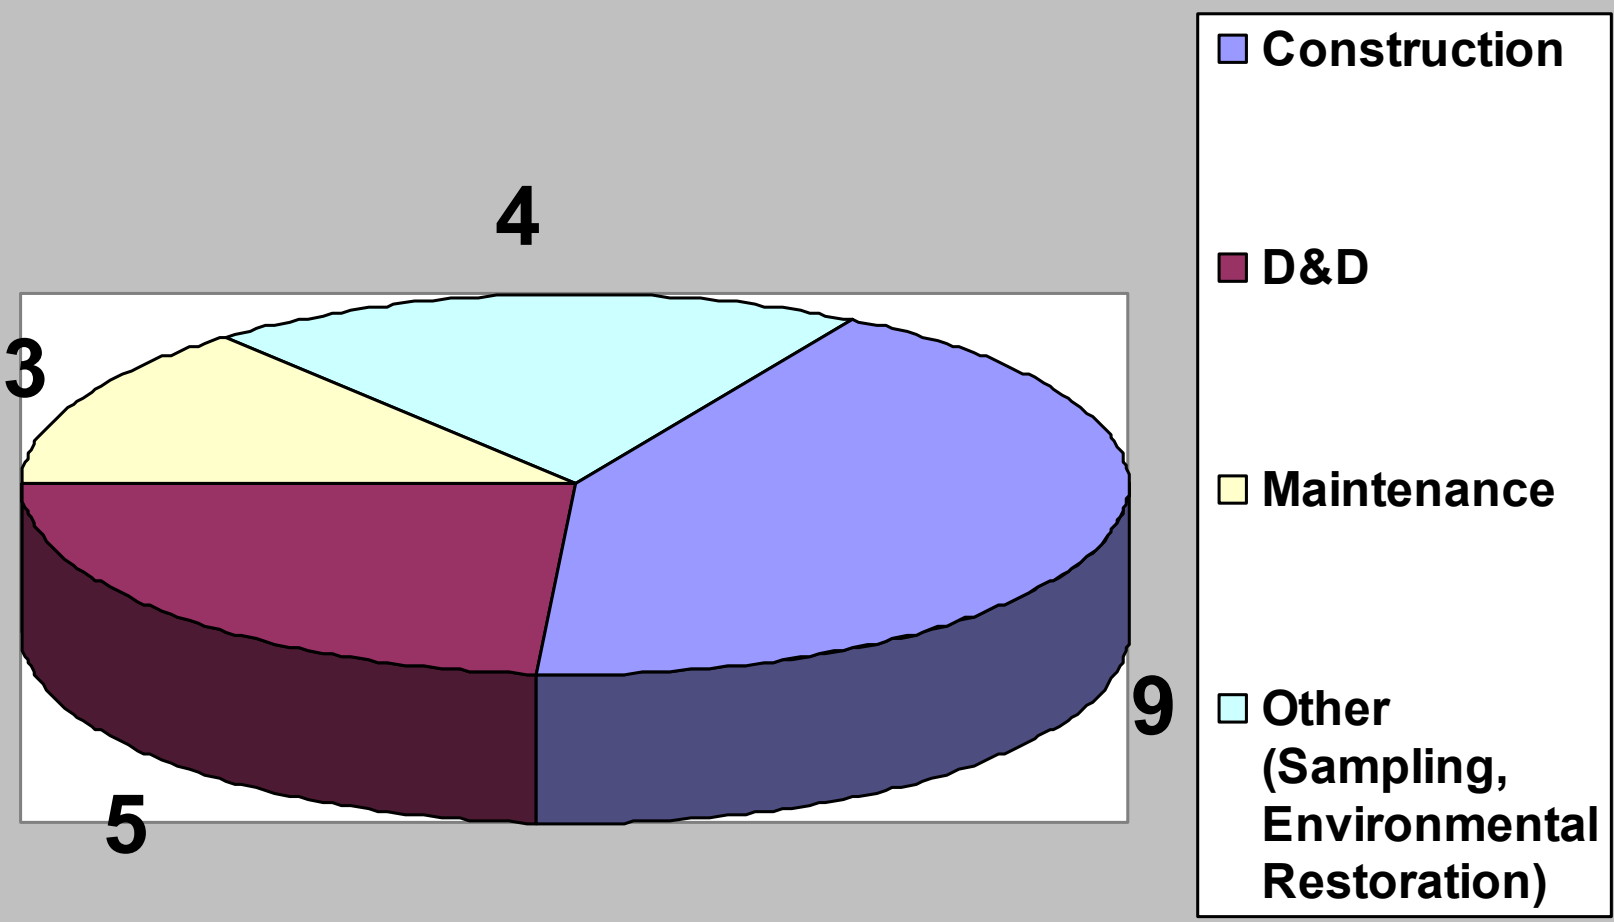
Activity

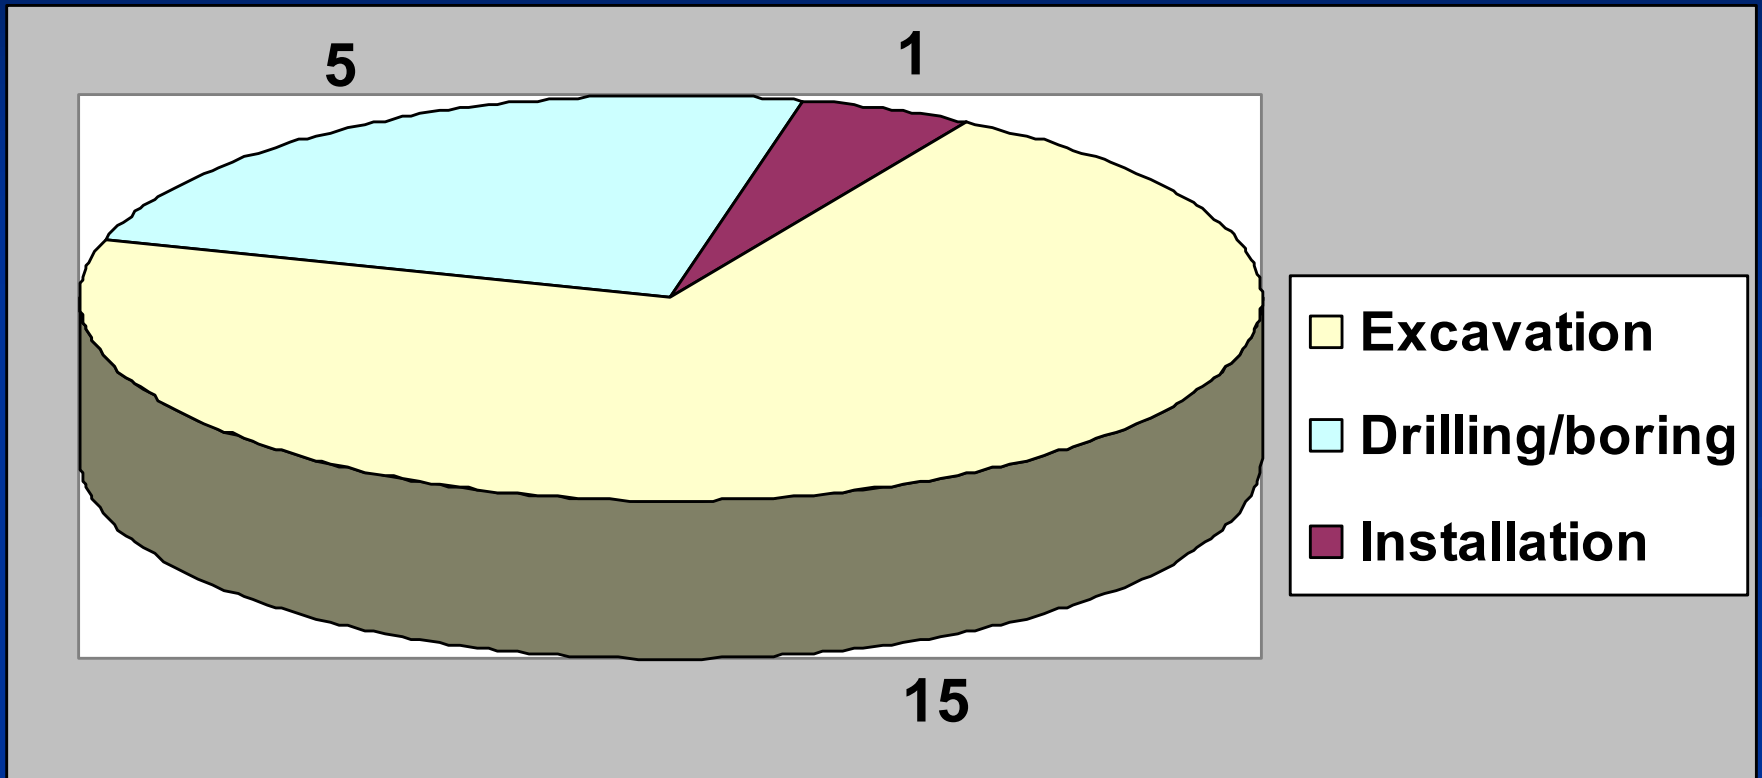
Figure 5. Specific Task

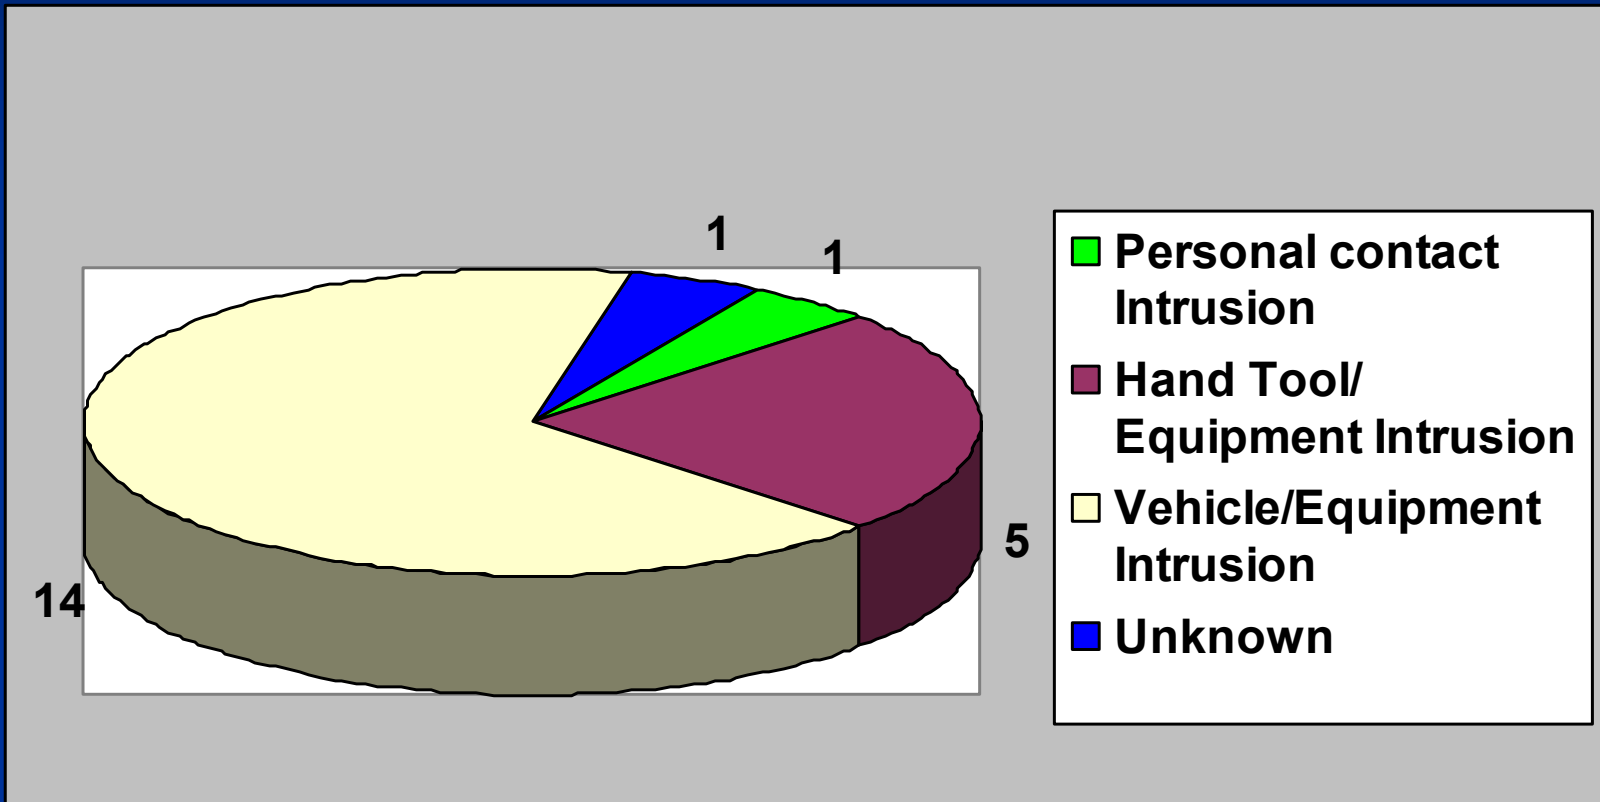
Figure 6. Cause

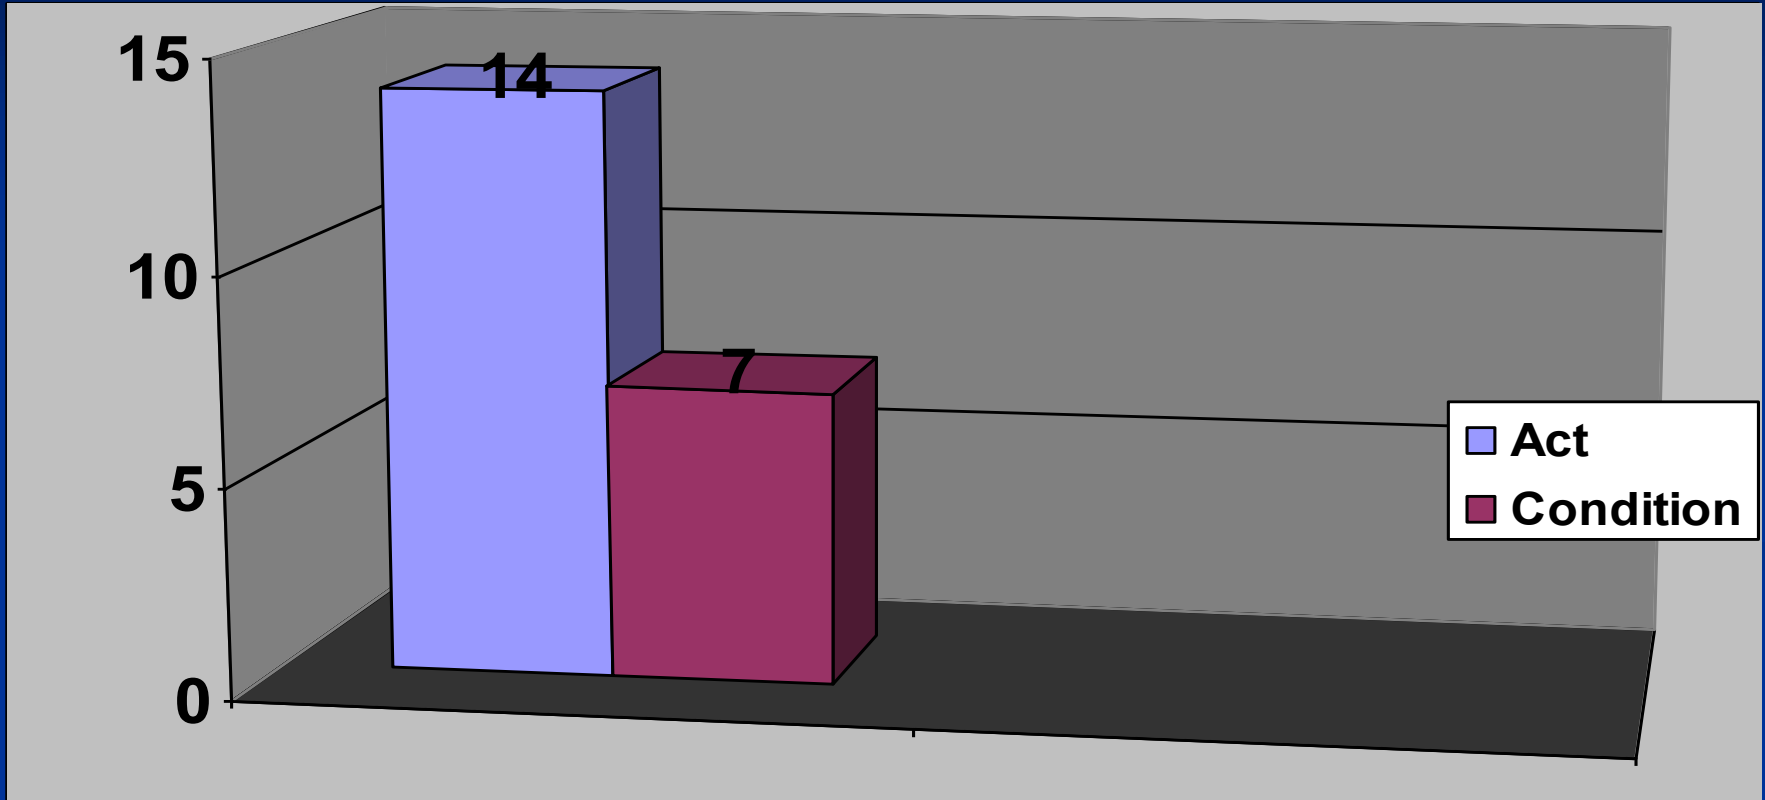
Figure 7. Unsafe act or Unsafe condition

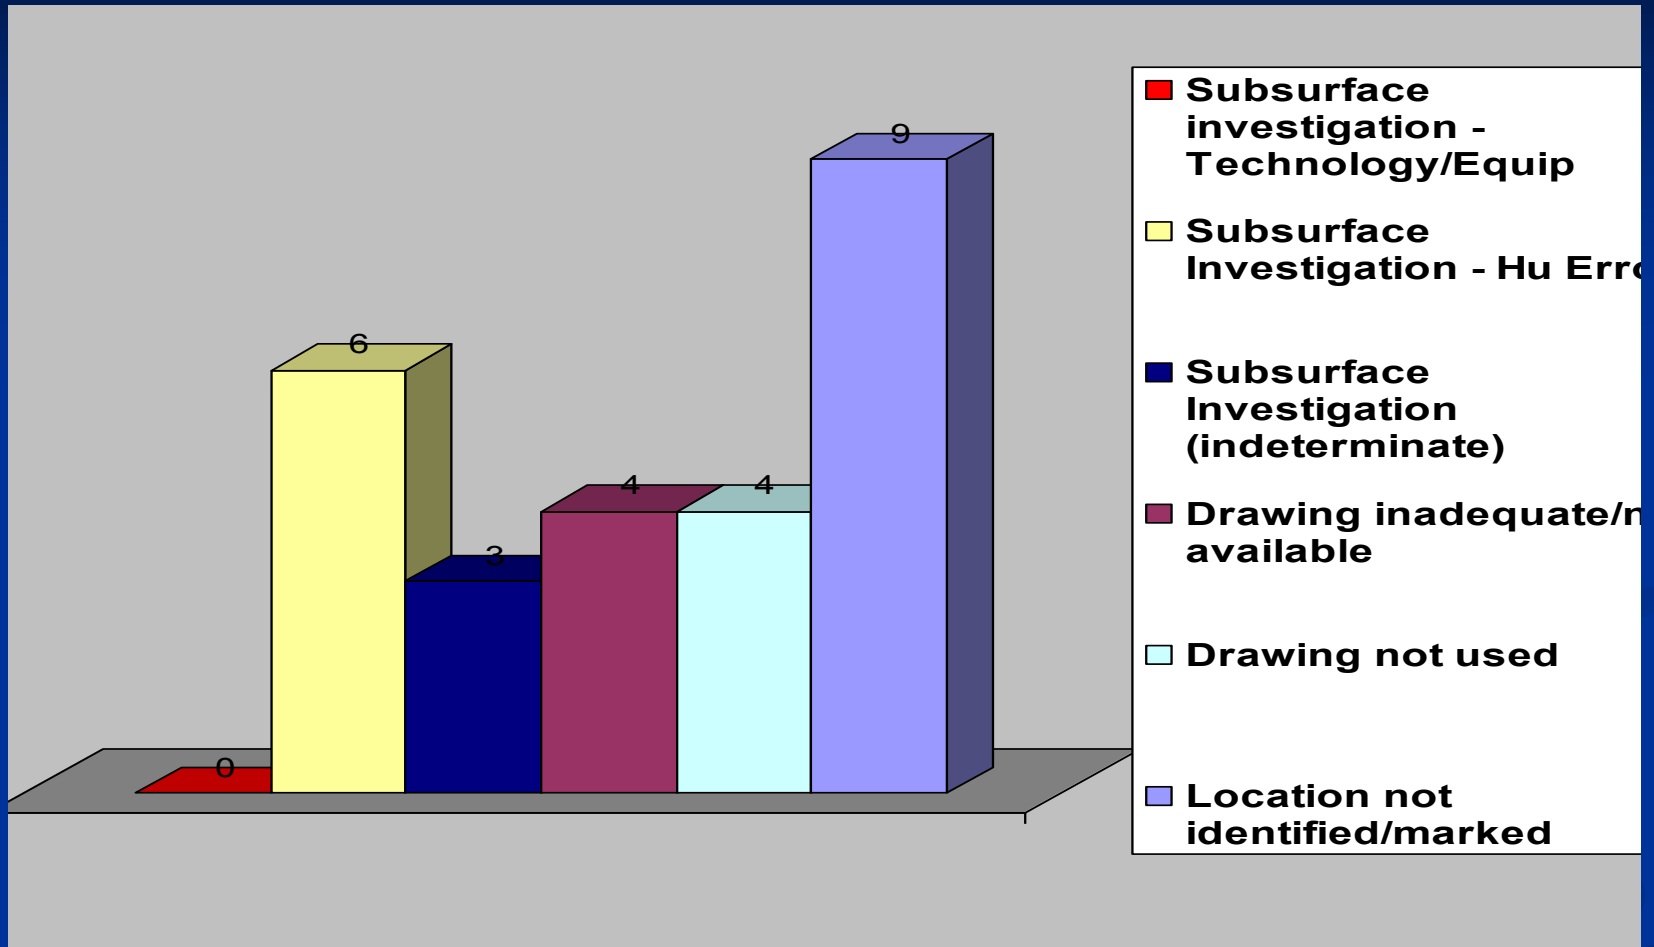
Figure 8. Issues/Factors

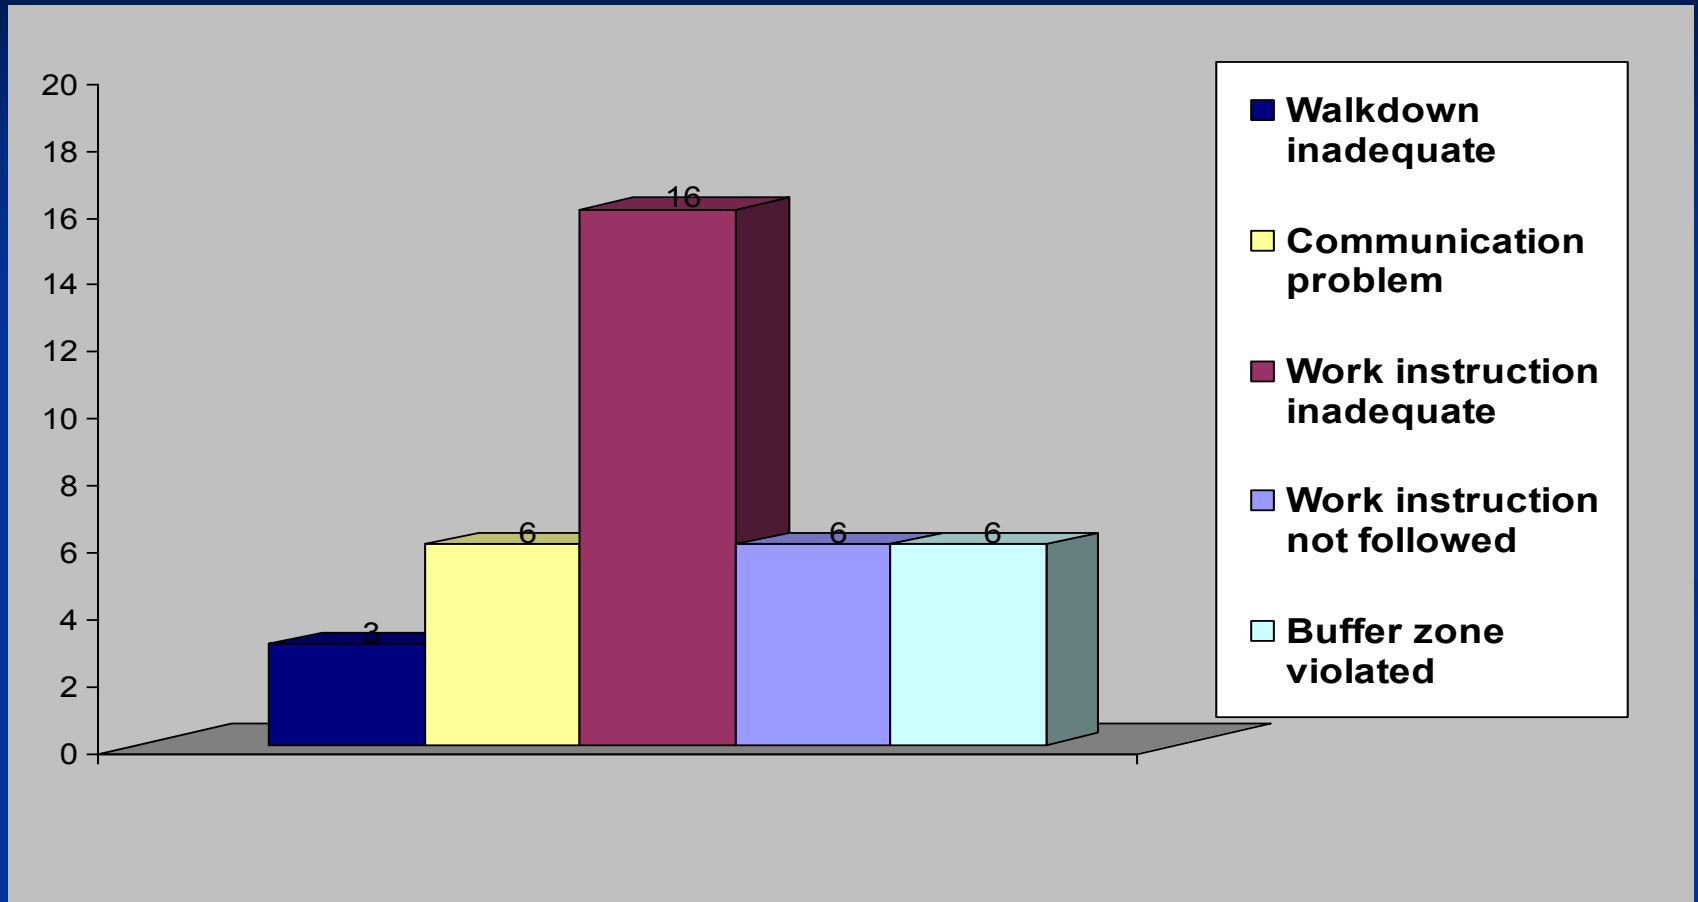
Figure 8. Issues/Factors

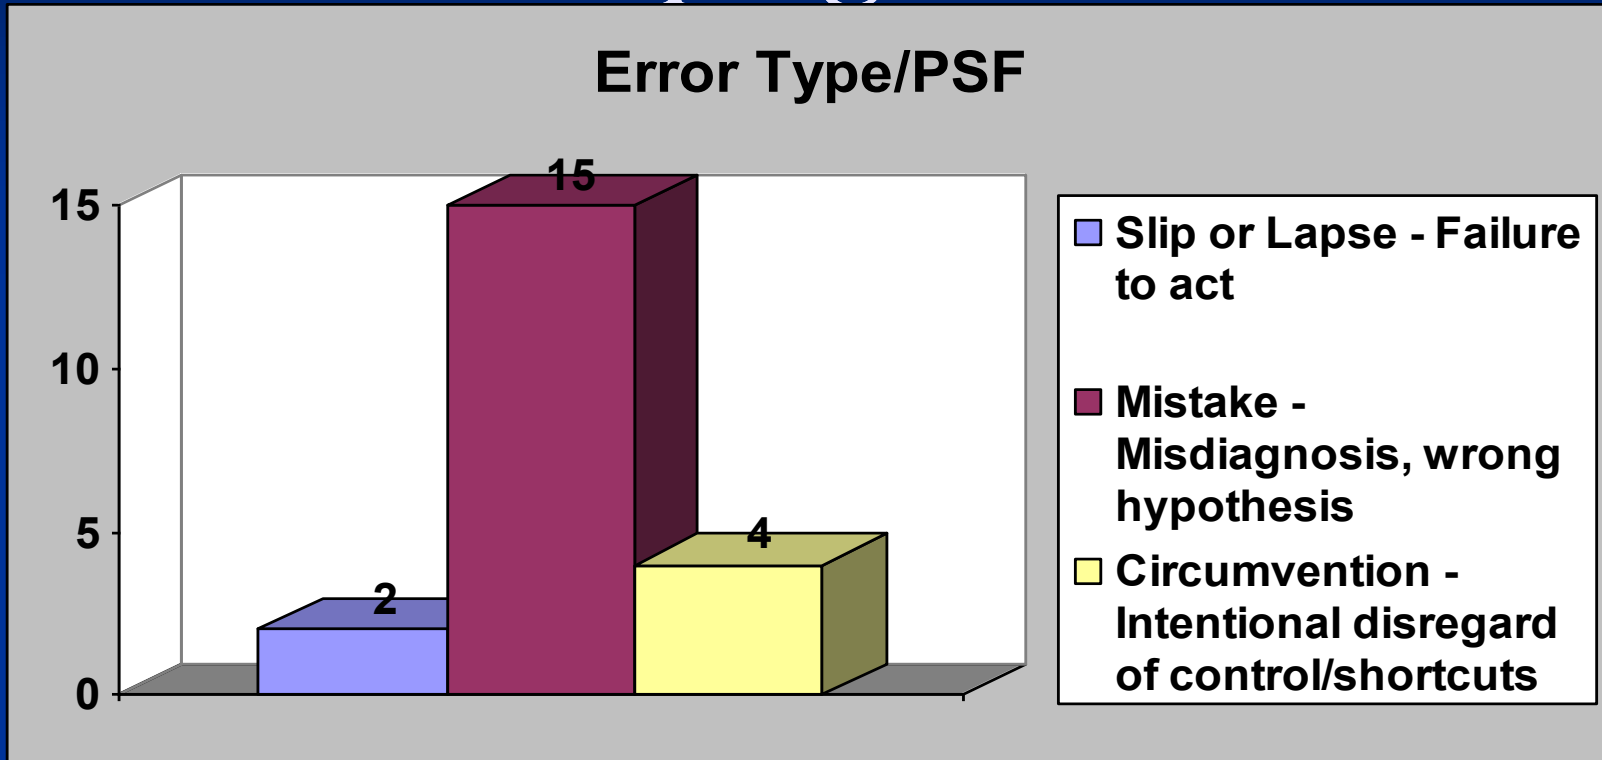
Figure 9. Error Type
