# BROOKHAVEN NATIONAL LABORATORY

## Sealed Source Leak and Off-Site Contamination

October 7, 2011

# Cesium (Cs-137) Source Failure

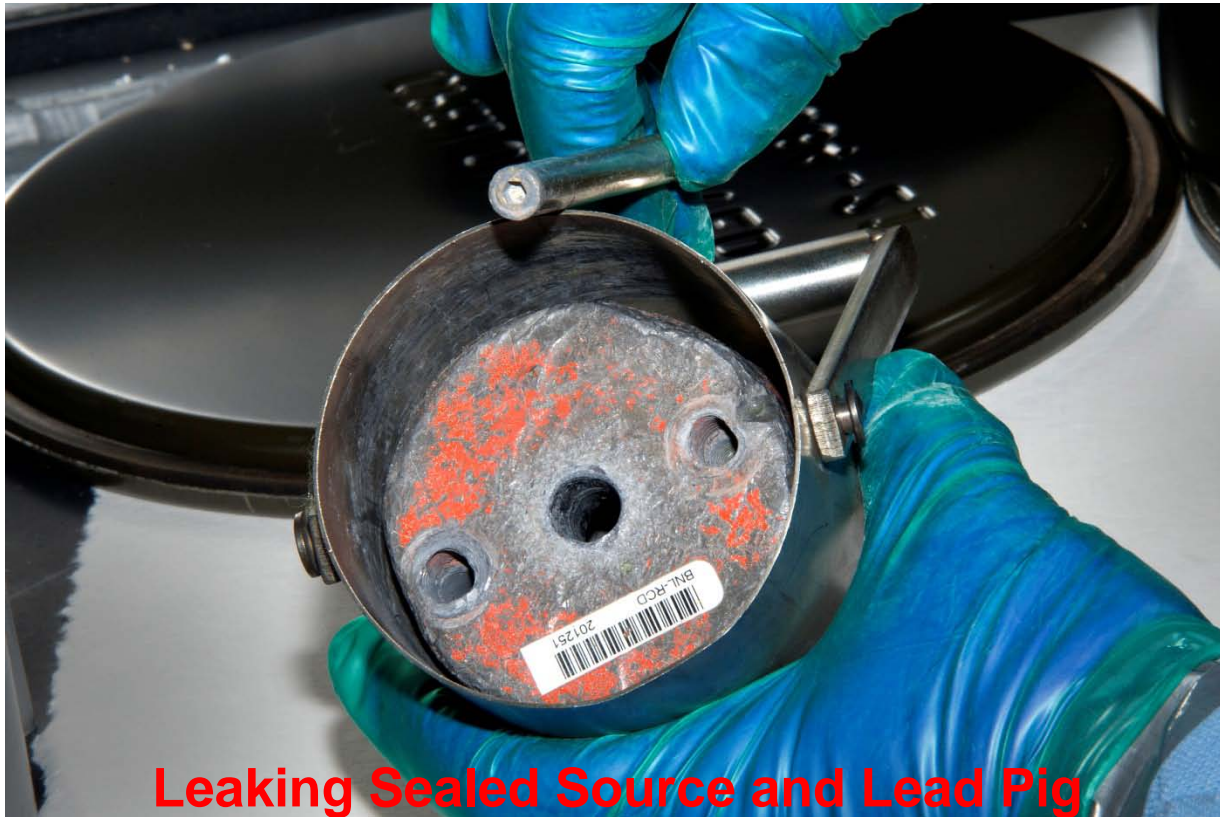
# Cs-137 Sealed Source and Lead Pig

- ❖ On September 28<sup>th</sup> @ ~1600 contamination of two Radiological Control Technicians (RCTs), several on-site locations, and a personal vehicle.
- ❖ Source of contamination was a Cs-137 (265 microcurie) source used to test area radiation monitors.
- ❖ Areas visited by the contaminated RCT
  - ✓ Bldg 923 Office and hall areas
  - ✓ Parking lot area of Bldg 923
  - ✓ Berkner Hall (no contamination found)
  - ✓ Passenger side of a personal vehicle owned by another lab employee
- ❖ Source is required to be leak checked semi-annually. Was last leak checked July 22, 2011 (passed with no leakage)

**Leaking Sealed Source and Lead Pig**

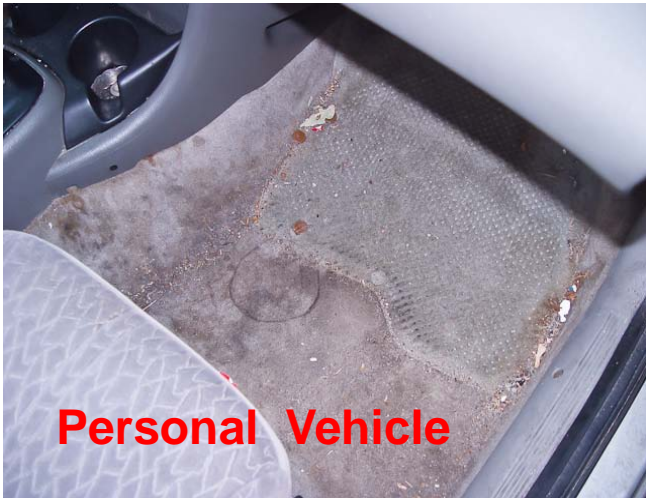
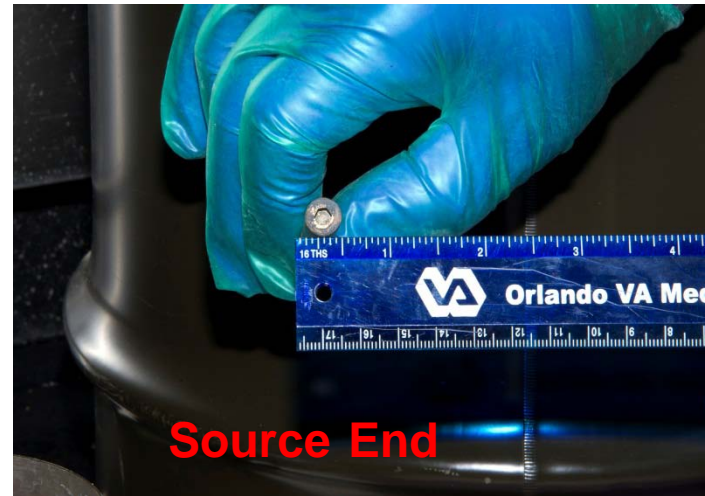
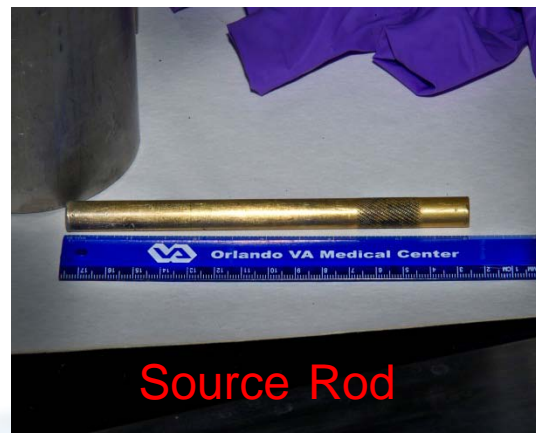
# Personal Vehicle and Source

- Upon discovery, outside of the passenger side door radiation reading 50 micro-rem/hour. The vehicle was decontaminated and will be released by close of business.

- On the passenger side two contamination spots were identified. On the floor mat 10,000 dpm and 3,000 dpm on the rug. A survey of the entire vehicle was completed, no other contamination identified. The personal vehicle owner was immediately notified, returned to the laboratory, surveyed and no contamination was identified. The contamination from the vehicle was removed and vehicle released.
