Lessons To Be Learned From BP Deepwater Horizon

Bill Rigot

Savannah River Nuclear Solutions

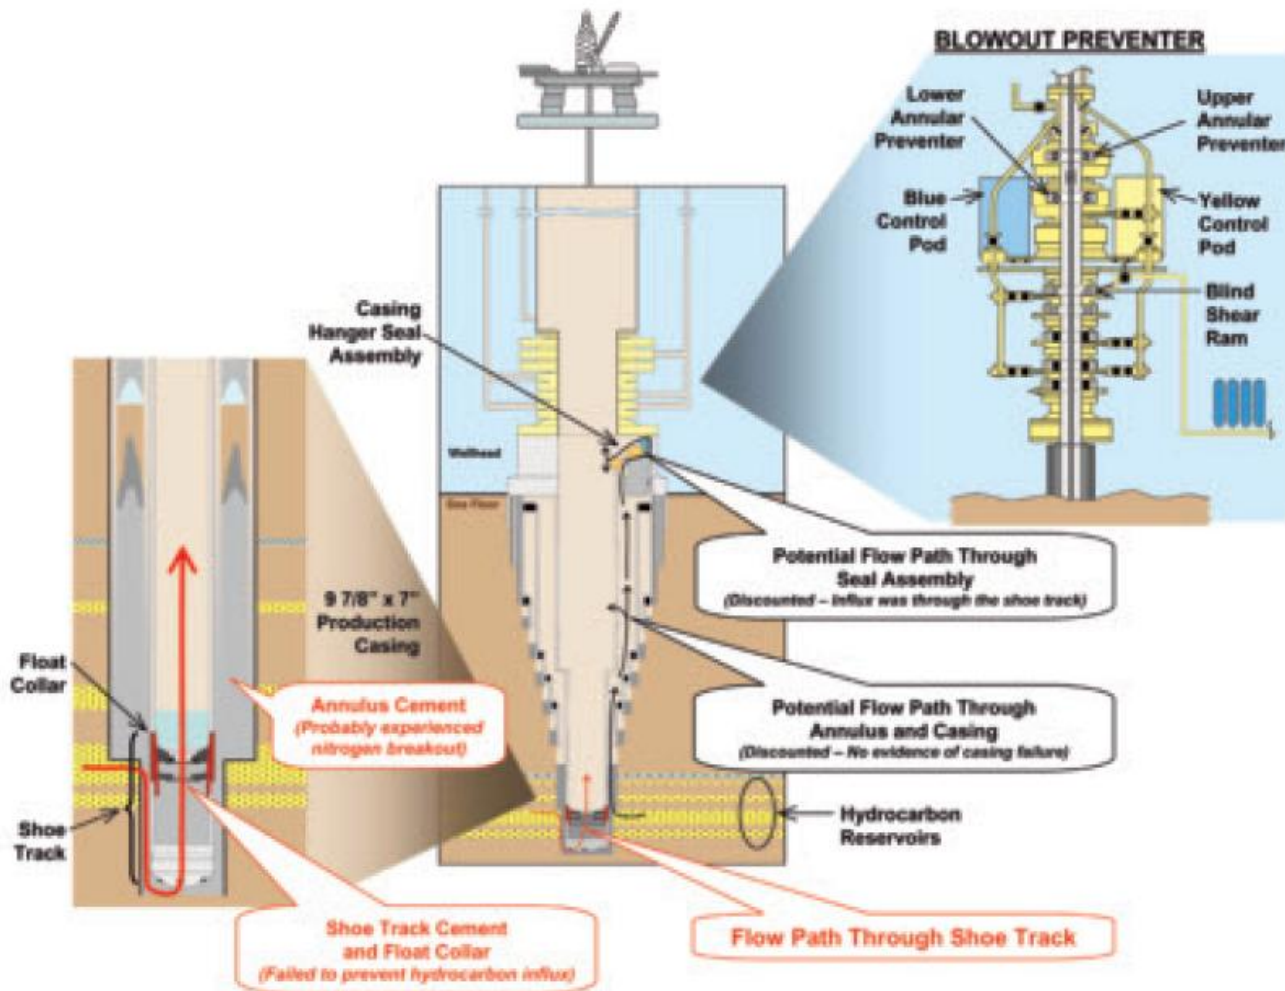
The Macondo Well

Annulus Cement Failure

- This was the primary physical barrier
- Cement had been poured the previous day into the wellbore annulus in preparation for moving the rig
- Weaknesses were noted in cement design and testing, QA, and risk assessment

Shoe Track Barrier Failure

- Both the shoe track cement and the float collar failed to allow hydrocarbons up the wellbore
- Potential common mode failure with failure of the annulus cement barrier
